Manhole Inspection Summary

Manhole # S65M__011MH

Insp Date: **5/14/08 11:00 AM**

Location Address: **1100 Broening Hwy.**

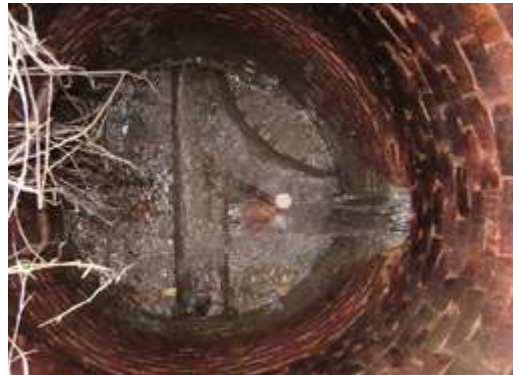
Top View

Comments **INCOMING DROP CONNECTION CLOGGED.**

Condition: ☐ Sound ☒ **Cracked** ☐ Leaks

Condition: ☐ Sound ☐ Cracked ☐ Root Intrusion ☒ **Loose Brick** ☒ **Deteriorated**

Infiltration: ☐ None ☒ **Joint** ☐ Cracks ☒ **Mortar** ☐ Roots ☐ Wall

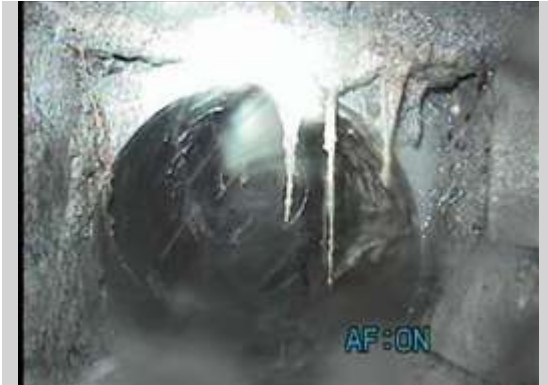
12 O'Clock Outflow

8 in. Circular Gravity Sewer
Pipe Out @ 12 O'Clock

Pipe Height: **8.4** (in.) Rod and Bar (Angled)
Pipe Material: **Clay** ☐ Pipe Lined
Invert Depth: **8.67** (ft.) Flow Characteristics: **Fast**
Deposits: ☒ None ☐ Mud ☐ Gravy ☐ Debris ☐ Grease
Silt Depth: (in.) Deposits Extent:
Infiltration: **None** Pipe Seal Cond: **Sound**

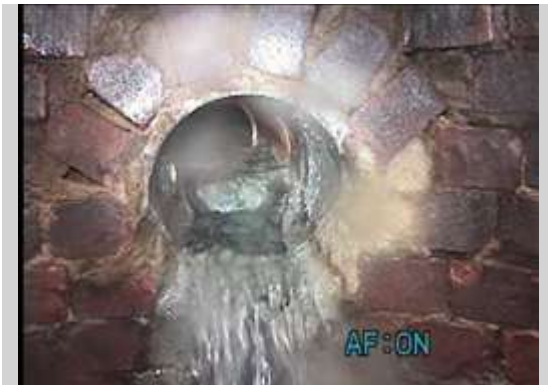
3 O'Clock Inflow

8 in. Circular Gravity Sewer
Pipe In @ 3 O'Clock

Pipe Height: **8.4** (in.) Rod and Bar (Angled)
Pipe Material: **Clay** ☐ Pipe Lined
Invert Depth: **5.42** (ft.) Flow Characteristics: **Fast**
Deposits: ☒ None ☐ Mud ☐ Gravy ☐ Debris ☐ Grease
Silt Depth: (in.) Deposits Extent:
Infiltration: **None** Pipe Seal Cond: **Sound**

Drop In @ 3 O'Clock

Drop: **Outside** Rod and Bar
Angled: **Yes** Reading: **7.58** (ft.)
Inv Depth: **8.58** (ft.)
Drop Condition: **Clogged**
